## **Aircraft Accident Brief**

**EgyptAir Flight 990  
Boeing 767-366ER, SU-GAP  
60 Miles South of Nantucket, Massachusetts  
October 31, 1999**

**NTSB/AAB-02/01  
PB2002-910401  
Adopted March 13, 2002**

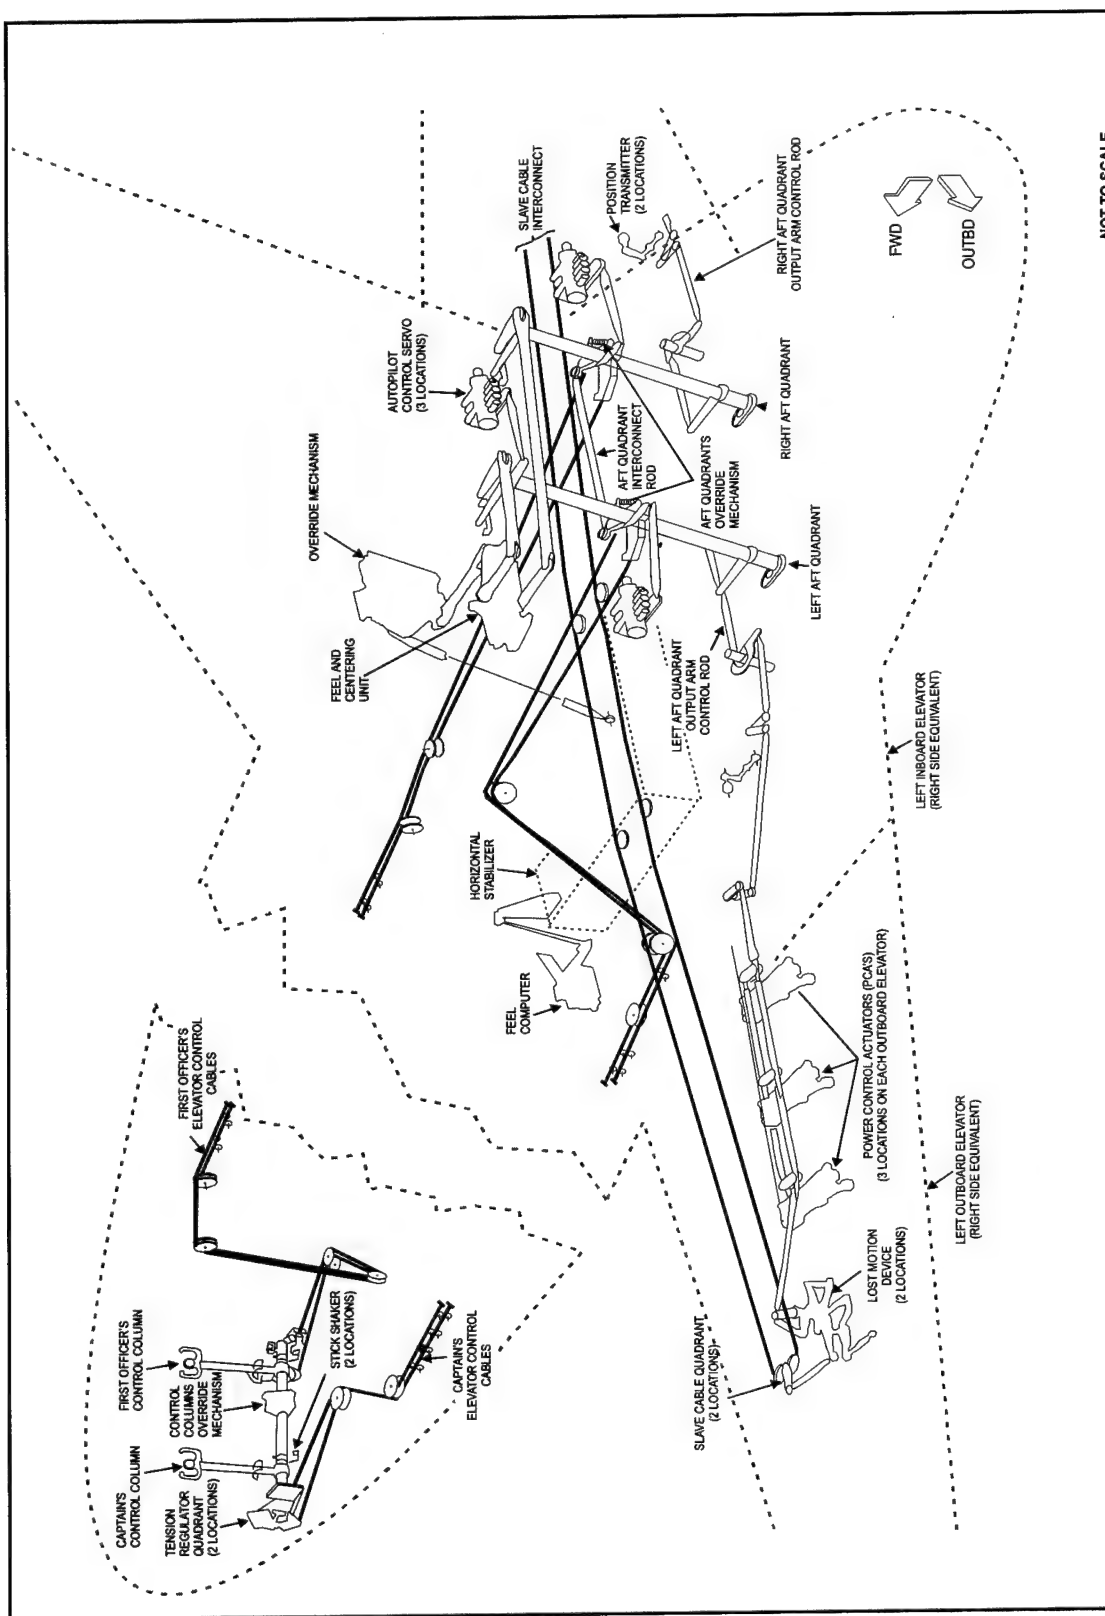
Figure 1a. Diagram of the components in the entire 767 elevator control system.

5. **(Page 15, footnote 32)** The routing of the cable in Figure 1a appears to be the opposite of the routing described in the footnote.
